PROTECTIVE COATINGS

STIRLING

Stirling Council were fighting a losing battle against flyposters until we applied our specialist high-profile coating.

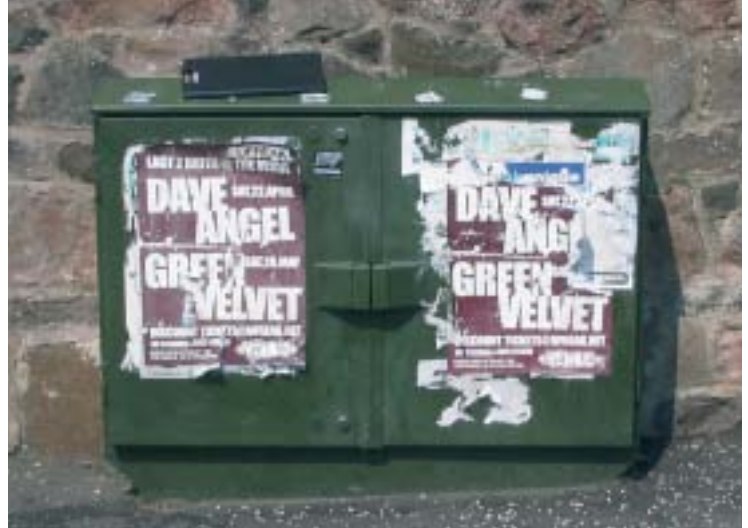
BEFORE

Unlike many of the UK's bigger towns and cities, Stirling in central Scotland was relatively free of litter and graffiti. However, large areas of the city centre and many of the surrounding routes had been targeted by flyposters.

It was a major problem – and a losing battle – for Stirling Council's Environmental Services department. No sooner had workers removed the posters from utility and traffic signal cabinets around the city centre, than the flyposters struck again.

Our team was based in Stirling for a week. After they stripped off the posters and washed the cabinets to remove all remaining city grime, the coating was applied in a four-stage process.

First, a primer was used to ensure good adhesion of the textured coating and to prevent corrosion. The textured coating was then applied – but only after carefully masking off all hinges, keyholes and openings. Two coats of our Anti-Graffiti Glaze completed the job.

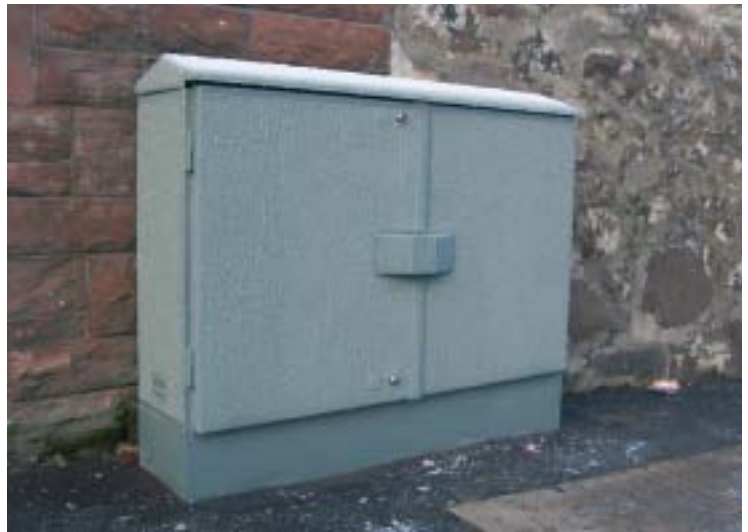
AFTER

The success of the project prompted Stirling Council to ask us to treat more cabinets with our Anti-Flyposting system. The textured coating thwarted the flyposters to such an extent that not one cabinet was targeted in the year after the work was completed.
