# INFRASTRUCTURE MAINTENANCE

## M11/M25 JUNCTION

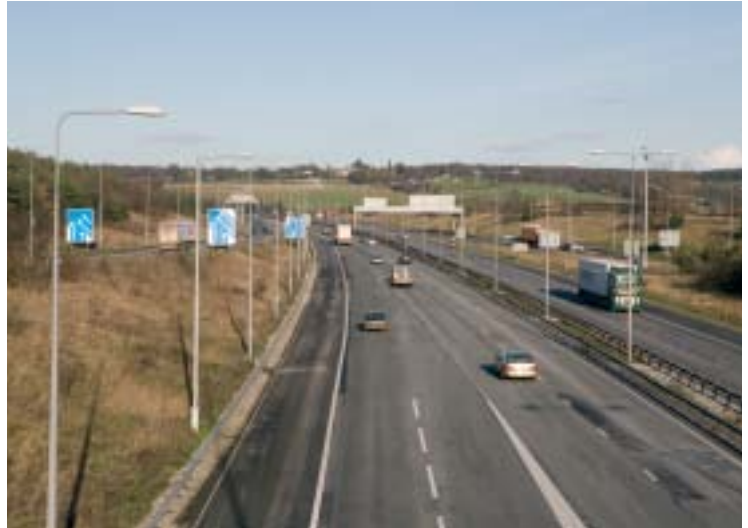
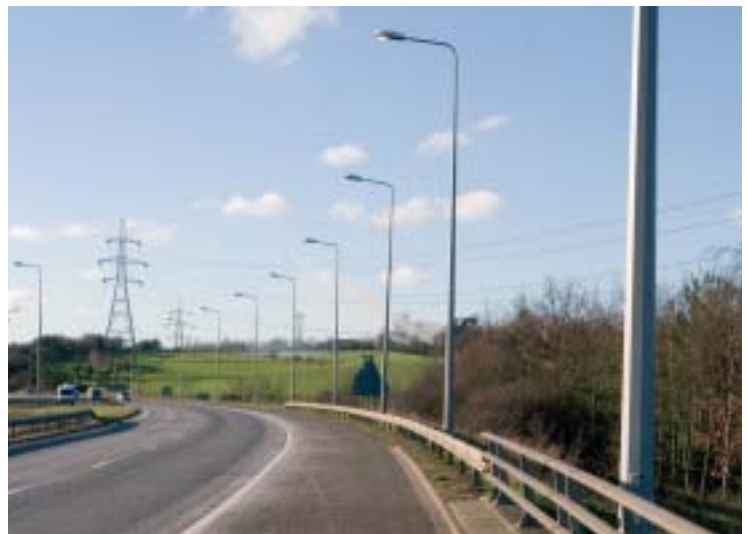
**Our contract to paint 450 lamp columns at the busy M11/M25 junction was completed in less than a month.**

The work was carried out from self-propelled hydraulic access platforms – highly efficient for this kind of work. All 450 lamp columns were cleaned and any rust or loose material was removed by wire brushing. A Micaceous Iron Oxide (MiO) primer was applied, followed by an MiO undercoat. The final coat was a modified vinyl MiO to BS 00 A 05.
